West City – Proposed Large Scale Development at Former DELL  
EMC Premises, Innishmore, Ballincollig, Co. Cork

COMBINED STAGE 1 & 2 ROAD SAFETY AUDIT

**February 2026**

| <b>Document No.</b> | 25016TT-MHL-Doc02-RSA-Rev A |

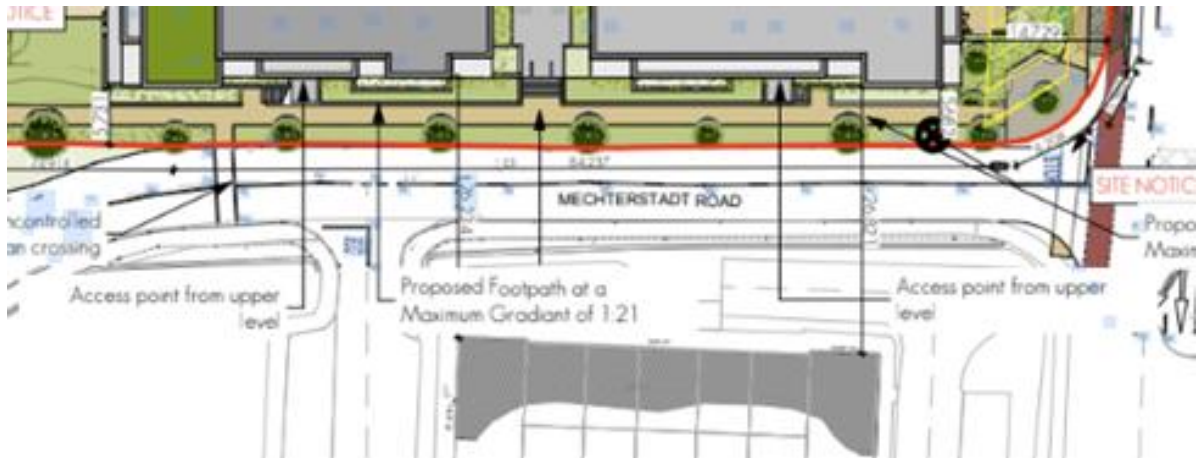
**Figure 2.1 Southern Site Boundary Adjacent Mechterstadt Road**

On the southern site boundary adjacent Mechterstadt Road there is an existing pedestrian crossing. No tactile paving is provided at the location and the parallel road markings are

reflective of a controlled (signal controlled) type crossing. The applicant drawings appear to indicate that the crossing is to be maintained at the location. Failure to provide a crossing designed to the correct standards may lead to confusion over priority at the facility, possibly leading to collisions involving crossing pedestrians.

Provide a suitable pedestrian crossing with tactile paving and designed in accordance with relevant design standards.

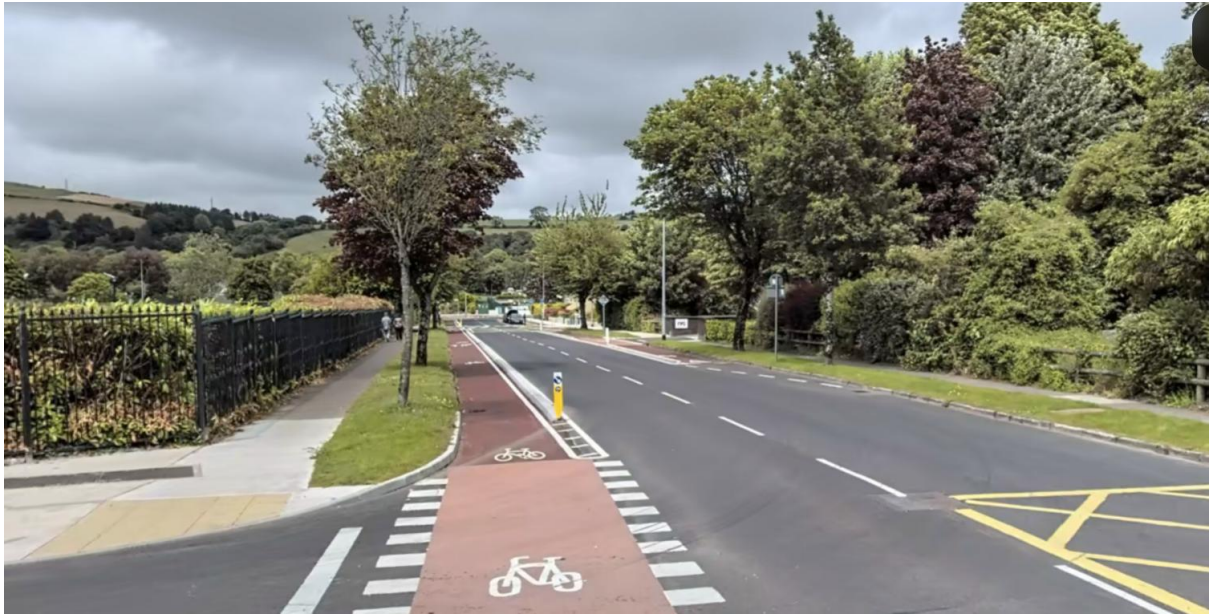
**Photo A.4.1 Site Boundary (Looking northwards along Innishmore Lawn Rd)**

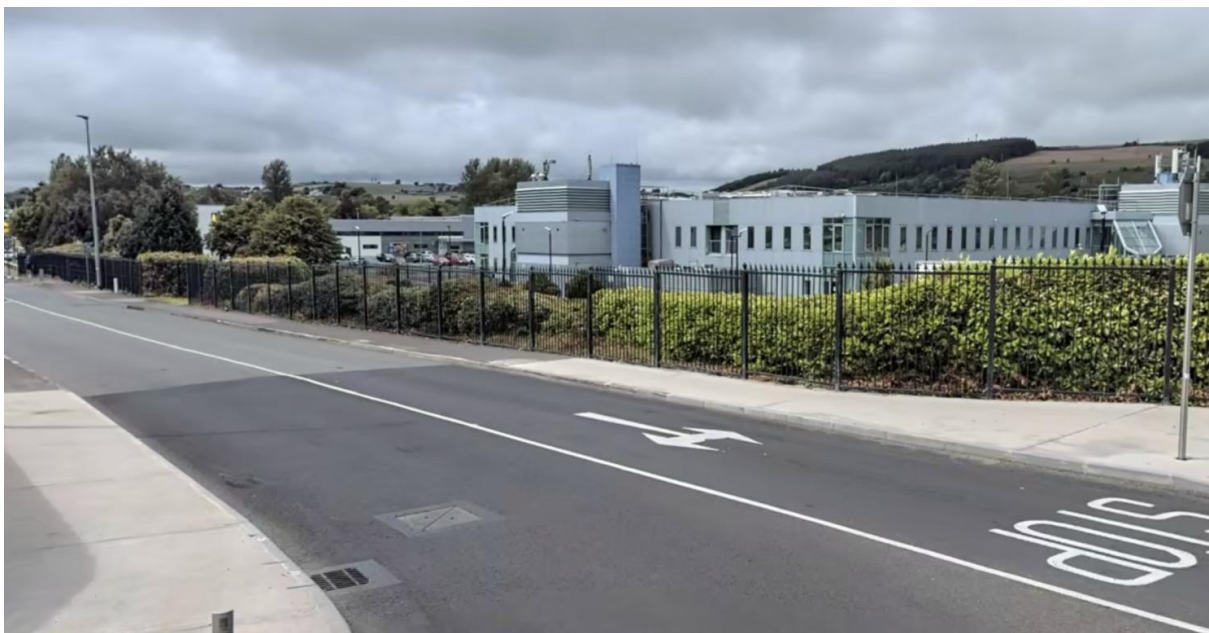
**Photo A.4.2 Site Boundary (Looking westwards along Mechterstadt Rd)**
